**Flood Control Project Maintenance  
Levee Inspections**  
**LMA District Cover Sheet**  
**Spring 2011 Levee Inspection Results**

**Reclamation District No. 0108 River Farms**

**Levee Inspection Report By Mile - Spring 2011**

Waterway						Bank	Unit Miles	Inspection Start/End	Inspector	
Unit No. 01 Colusa Basin Drain						Left	20.59	04/20/2011 04/20/2011	John Williamson	
LMR No.	Levee Mile		Category	Item	Location	Rating	Action/Comment	GPS Latitude/Longitude		Issue No. Photo
	Start	End						Start	End	
1	0.10	20.59	Earthen Levee	Vegetation	LS	M	Control annual grass and weeds on the levee slopes and easements.	38.823106 ° -121.797504 °	39.033945 ° -121.993319 °	1 Y
2	0.10	20.59	Earthen Levee	Vegetation	WS	M	Control annual grass and weeds on the levee slopes and easements.	38.823105 ° -121.797504 °	39.033945 ° -121.993319 °	2 Y
3	1.05	2.54	Earthen Levee	Crown Surface / Depressions / Rutting	CR	C	Keep the crown roadway free of vegetation.	38.828439 ° -121.813635 °	38.836600 ° -121.839358 °	3
4	5.56	5.56	Earthen Levee	Animal Control	LS	W	Exterminate rodents and backfill and compact or grout burrows.	38.848592 ° -121.893017 °	38.848592 ° -121.893017 °	22

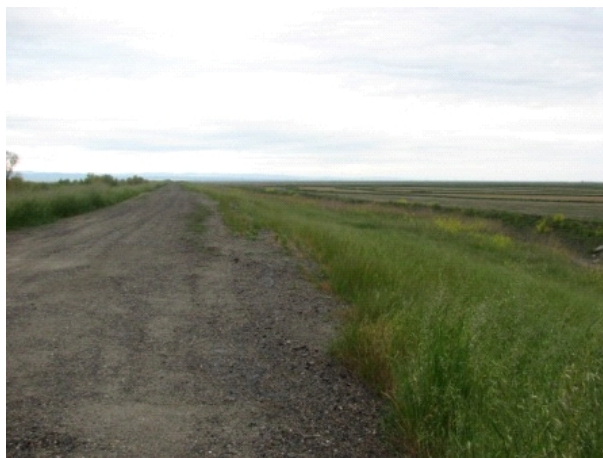
johngw\_s\_20110425\_451.jpg

Levee Mile Report Line	1
Start Levee Mile	0.10
End Levee Mile	20.59
Location	Land Side
Category	Earthen Levee
Item	Vegetation

The grasses are taller than 12" on both side of the levee.

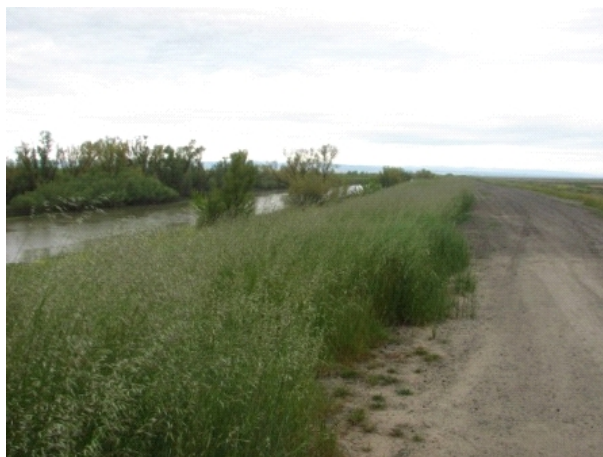
johngw\_s\_20110425\_450.jpg

Levee Mile Report Line	2
Start Levee Mile	0.10
End Levee Mile	20.59
Location	Water Side
Category	Earthen Levee
Item	Vegetation

The photo is the waterside levee slope of the grasses.

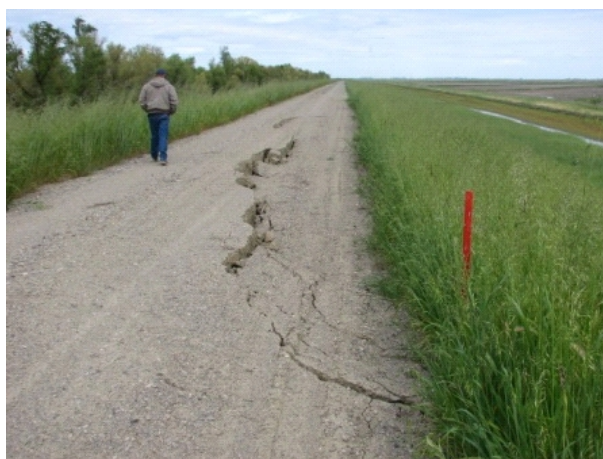
johngw\_s\_20110425\_452.jpg

Levee Mile Report Line	10
Start Levee Mile	13.74
End Levee Mile	13.74
Location	Land Side
Category	Earthen Levee
Item	Slope Stability

A slough has occurred during the high water of this winter.

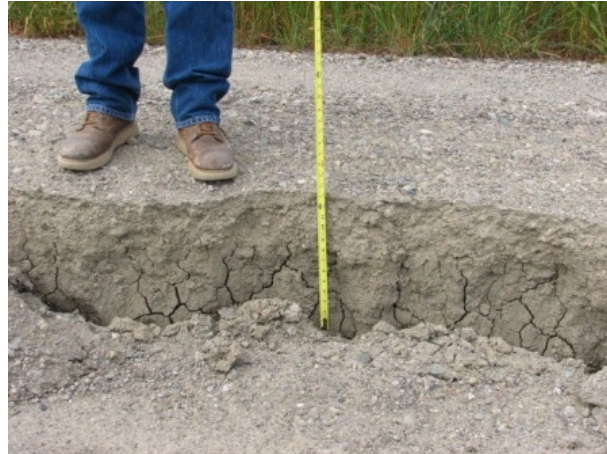
johngw\_s\_20110425\_453.jpg

Levee Mile Report Line	10
Start Levee Mile	13.74
End Levee Mile	13.74
Location	Land Side
Category	Earthen Levee
Item	Slope Stability

The slough has dropped 13" in the center of the crown and runs 85' in length.

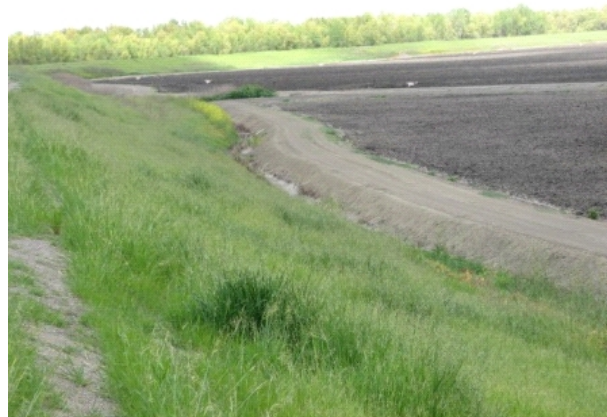
johngw\_s\_20110228\_174.jpg

Levee Mile Report Line	11
Start Levee Mile	18.88
End Levee Mile	19.60
Location	Land Side
Category	Earthen Levee
Item	Encroachments

Ag. ditch

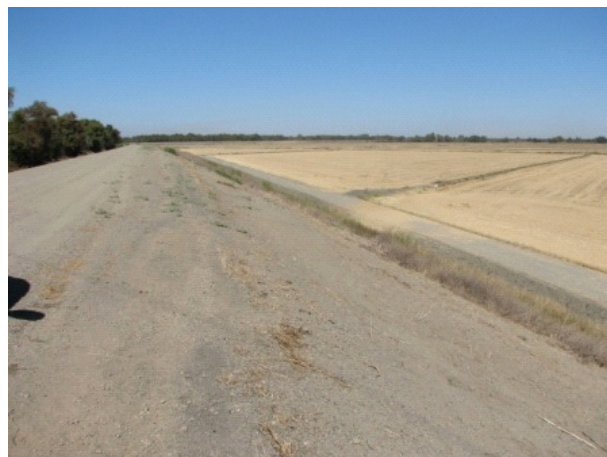
johngw\_s\_20110228\_175.jpg

Levee Mile Report Line	11
Start Levee Mile	18.88
End Levee Mile	19.60
Location	Land Side
Category	Earthen Levee
Item	Encroachments

Ag ditch along toe of landside

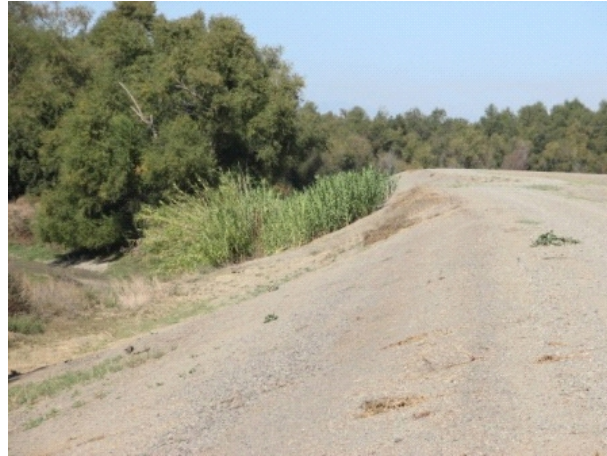
johngw\_s\_20110228\_176.jpg

Levee Mile Report Line	13
Start Levee Mile	19.27
End Levee Mile	19.27
Location	Water Side
Category	Earthen Levee
Item	Vegetation

Arundo is growing on the slope.

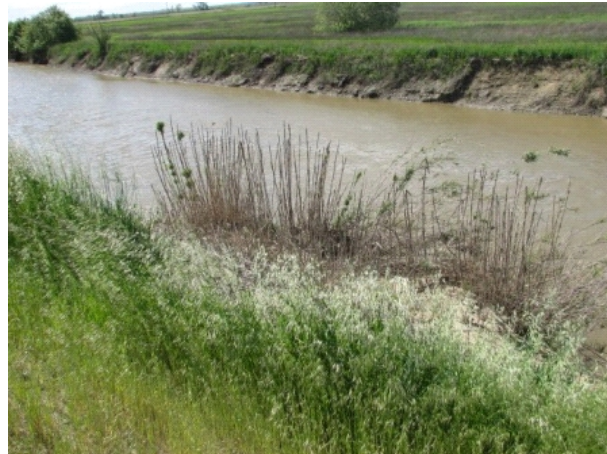
johngw\_s\_20110425\_454.jpg

Levee Mile Report Line	13
Start Levee Mile	19.27
End Levee Mile	19.27
Location	Water Side
Category	Earthen Levee
Item	Vegetation

The district has made great efforts to eliminate the Arundo.
